## DIY Repair to RX7's Tachometer Solder Joints

The repairs described herein are some that I did to my own '95 PEP. In my case this definitely improved my tach's behavior, but like all things your mileage may vary.

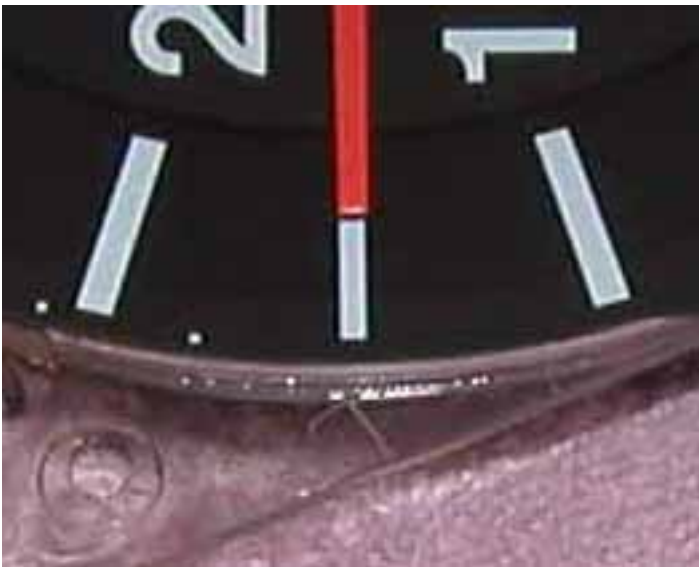
One of my marks in the shape of an upside-down 'V' is straight across from the needle. No magic in that I choose a convenient RPM mark. Not showing well is a second mark I made across from one of the small white dots around the outer edge of the face. I found this second mark to be the most help in aligning everything during re-assembly. Having several marks is cheap insurance.

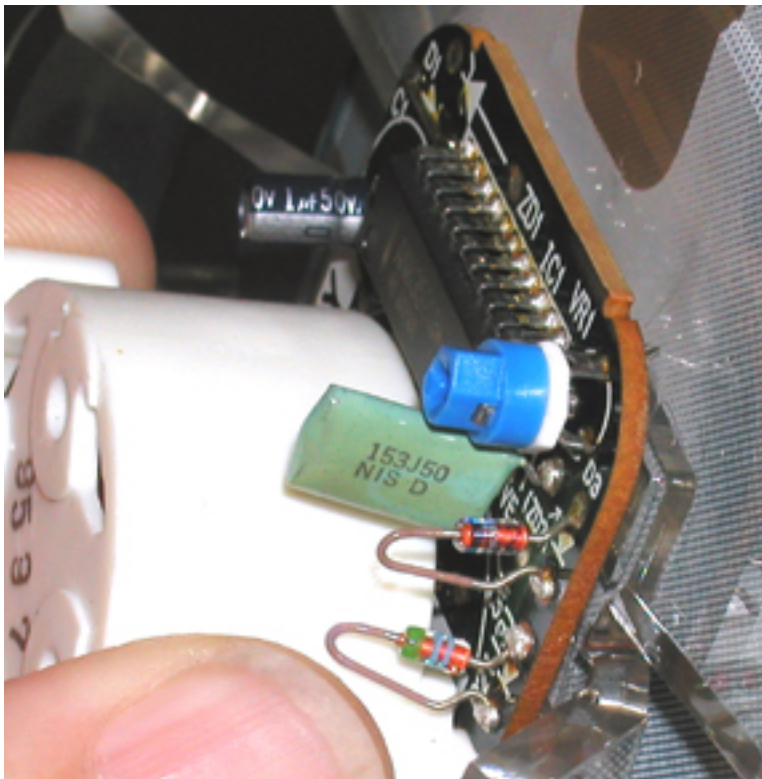
I recommend that you remove and replace the two capacitors first, and then simply re-solder everything else. Note that the electrolytic capacitor is polarized. It's the black colored cylindrical part with a silver stripe just above center in the following picture. Be sure that you insert the replacement in the same orientation.

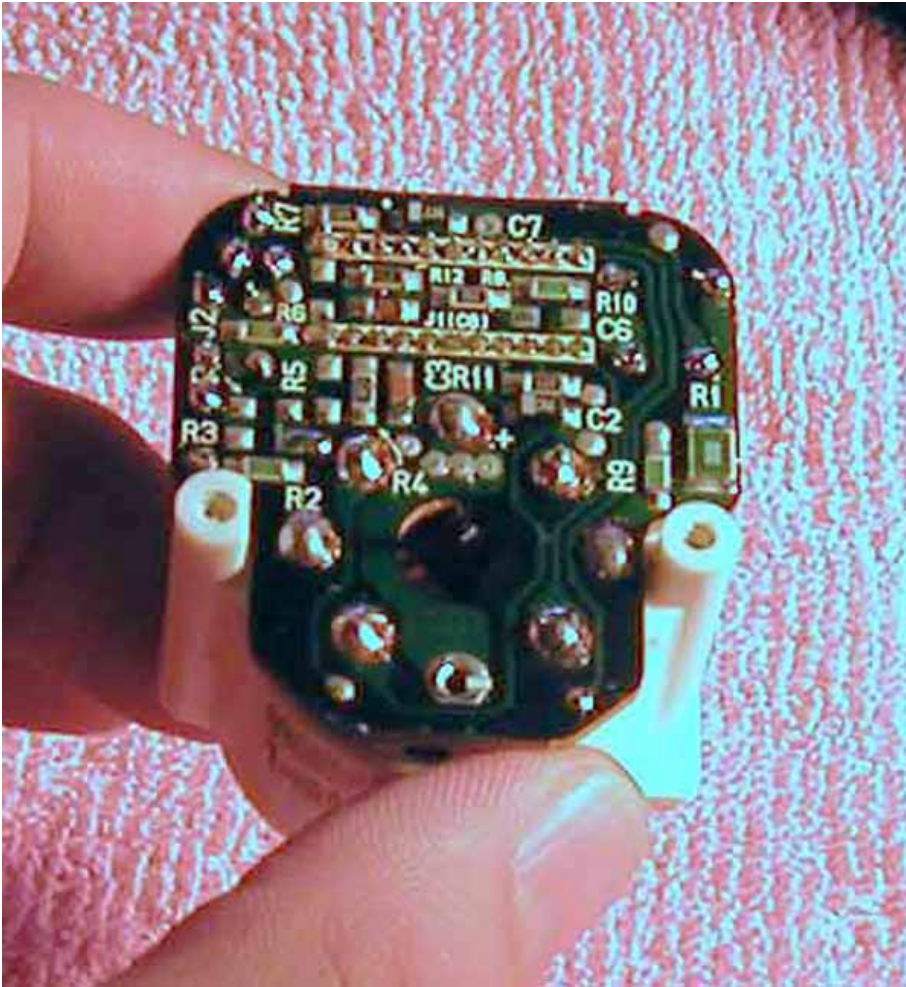
Watch out that you don't create a solder bridge where it's not supposed to be. If that happens you can use the soldering pencil to melt the solder away. You can't tell much, but below is a picture of the circuit –side of the tach motor after re-soldering. The circuit board is less than 2 inches across.

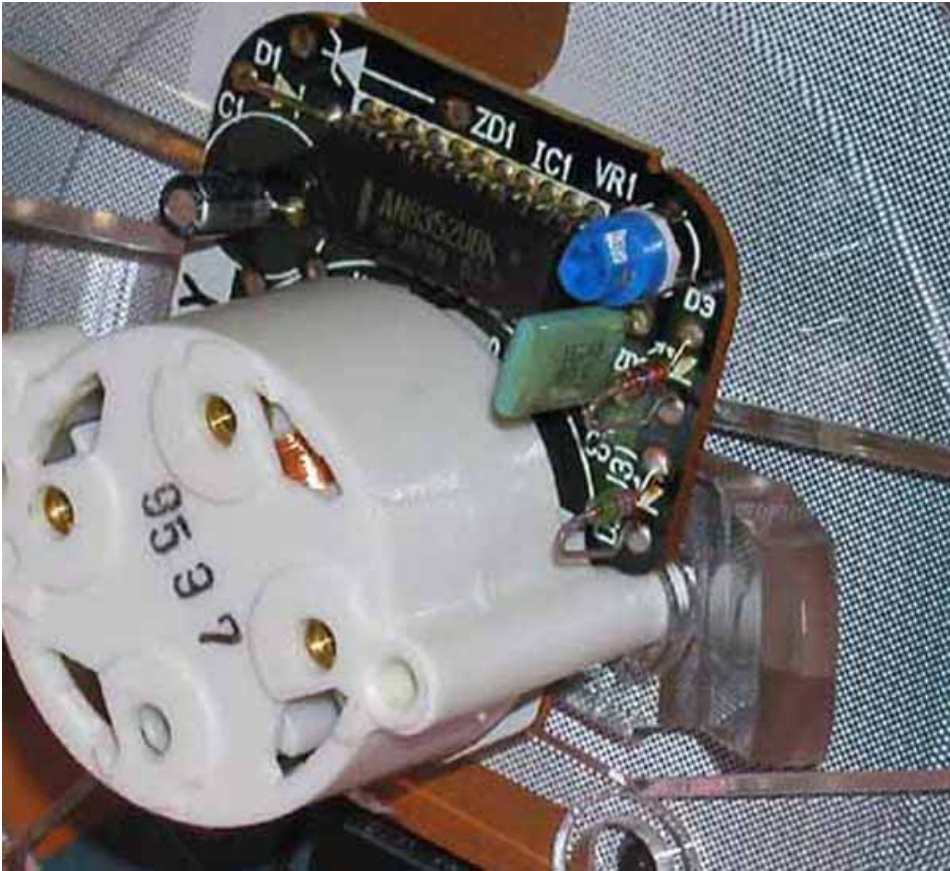
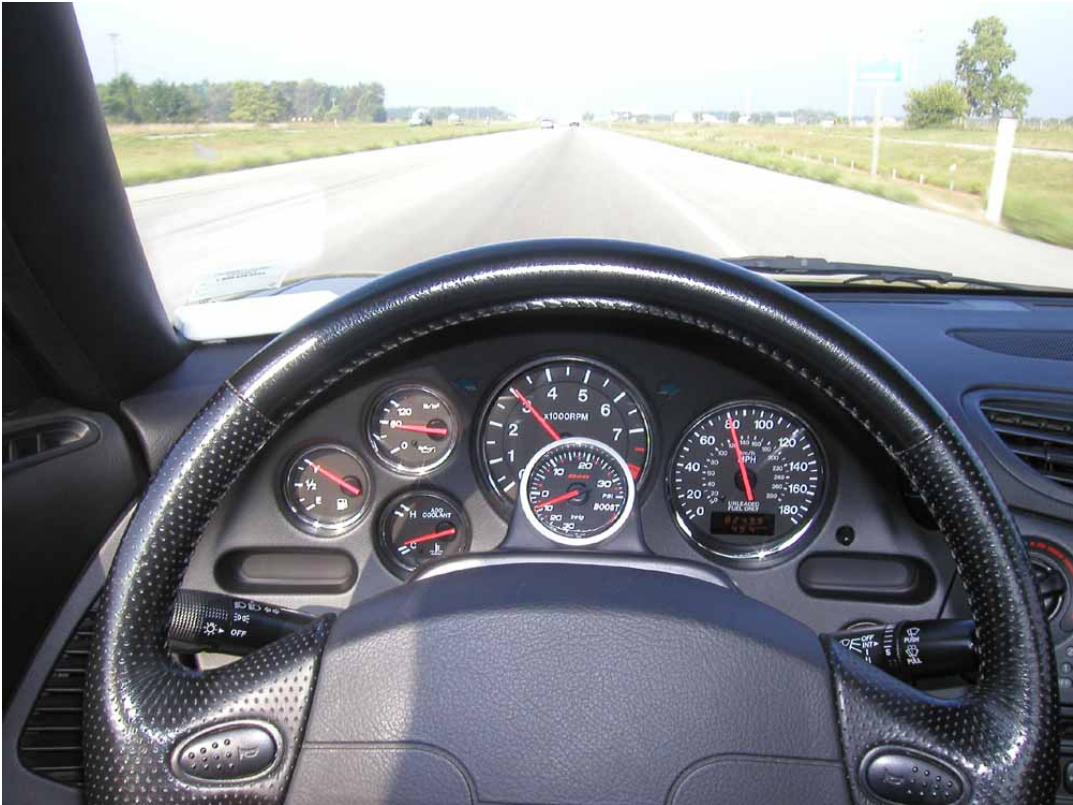
On the back of the tach motor is a small blue-colored potentiometer that I suspect the factory used to calibrate the tach. There are only three wires that attach via the tach motor's mounting screws; power, ground, and signal. I did NOT attempt to make any changes, but thought I'd point out the possibility for future explorers. Someone would need to determine the type and amplitude of signal the tach expects; square wave or pulse for example.
