## DIY Repair to RX7's Tachometer Solder Joints

The repairs described herein are some that I did to my own '95 PEP. In my case this definitely improved my tach's behavior, but like all things your mileage may vary.

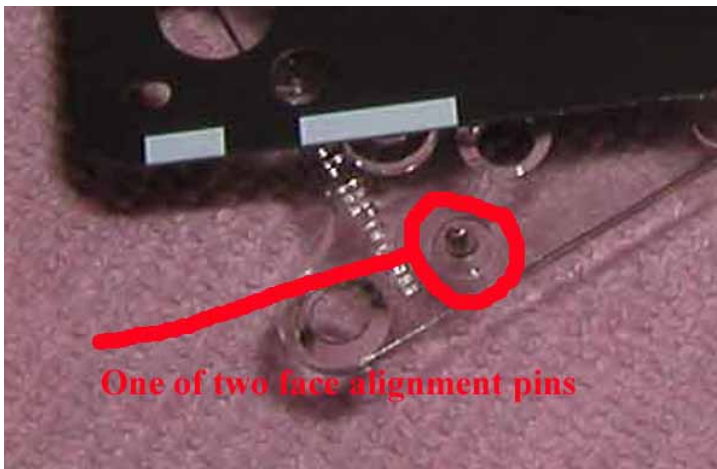
I discovered that you could lift the outer edges of the tachometer's face off of the two raised plastic pins that are molded in to the clear backing, and then **rotate the face counter-clockwise**. I assume this is the reverse of how the tach was originally assembled, but I didn't find any other references to this.

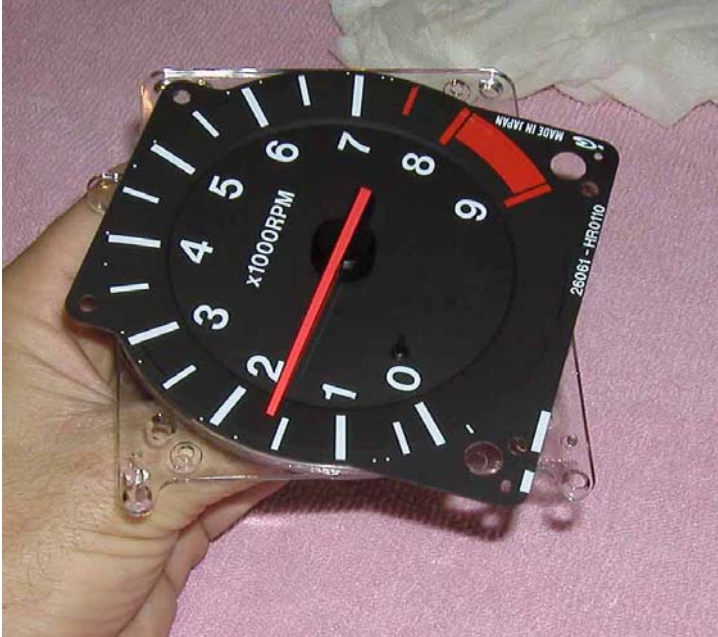
The 'stop' pin attached to the face that normally limits the needle's CCW rotation at the zero RPM line moves too allowing the needle to follow. But as you continue to rotate the face CCW the needle itself stops after about 45 degrees of rotation.

At that point some type of internal limit inside the motor assembly stopped the needle's CCW rotation. It became an easy task to simply scratch alignment marks into the plastic.

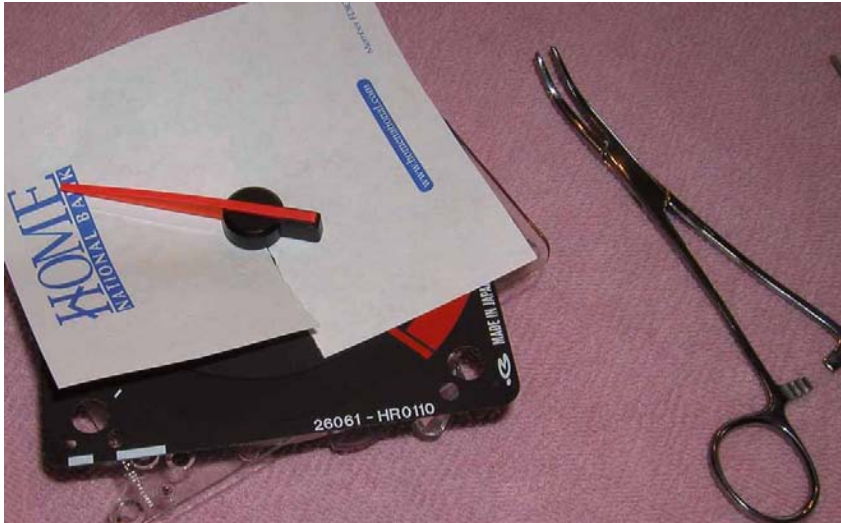
The flat black paint on the face shows *everything*, so be sure to wash your hands before you touch it. I used a sheet of paper around the shaft for more protection. It was easy to pull the needle off by gripping the red portion on both sides of the black hub and pulling. But don't pull on the black hub itself, as it is easily broken. Measure the spacing between the needle and the face before you start so you can match this spacing during re-assembly.

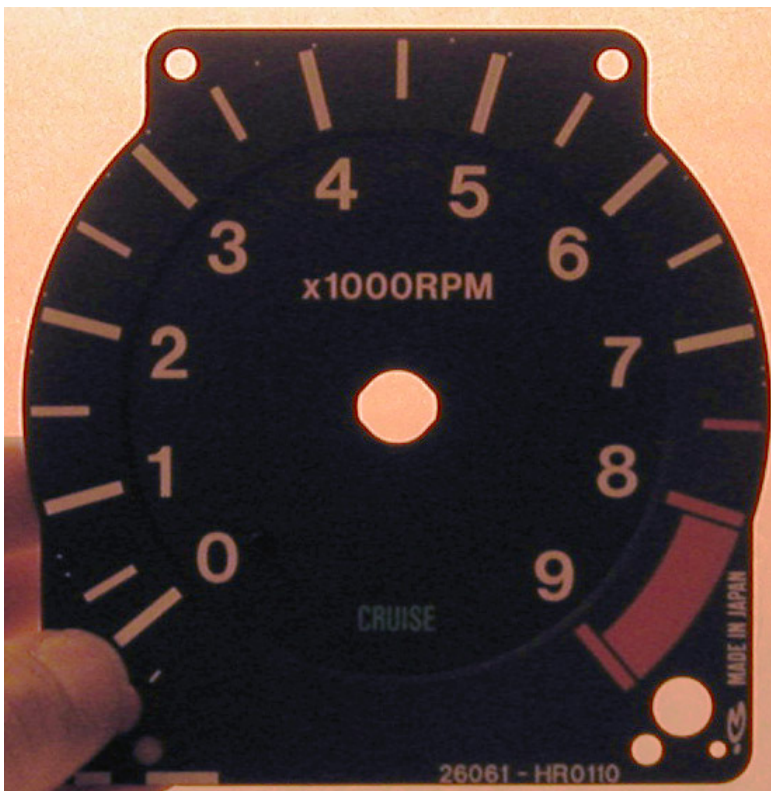
With the needle removed you continue to rotate the face CCW to about 90 degrees, and at that point the center 'hole' releases the two tabs on the clear plastic backing. When replacing the face just align these tabs, press the face's center hole over them, and rotate CW.
